Post Incident Analysis for 10109 Lorain Ave

Single Family House Fire June 29th, 2009 10109 Lorain Ave FS16's area

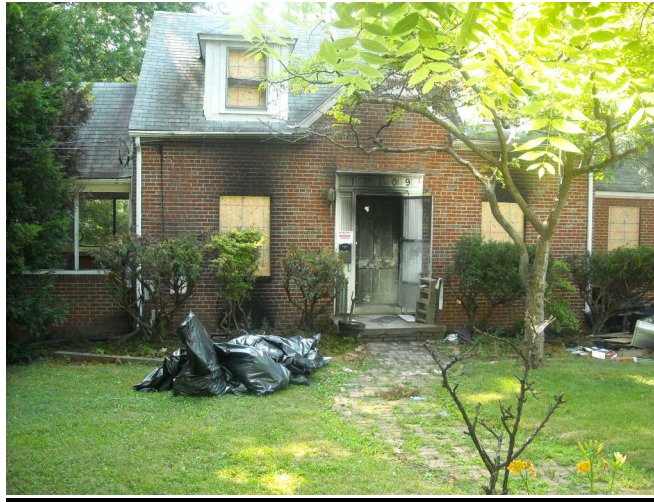
- Report of one trapped
- One injured civilian
- Four injured Fire Fighters
- Fire in basement
- House had been divided into three separate living units
